CIRCULAR OF THE BUREAU OF STANDARDS

No. 113

STRUCTURE AND RELATED PROPERTIES OF METALS

JULY 7, 1922

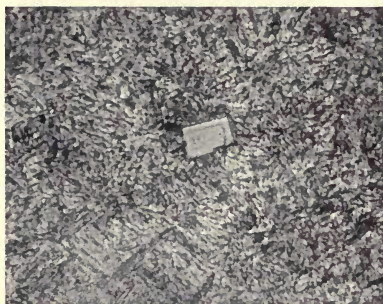
FIG. 17.—Characteristic appearance of an inclusion caused by the addition of titanium to steel.
× 1000

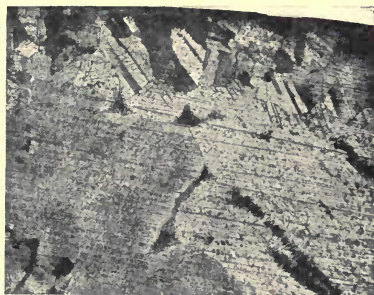
FIG. 26.—Microstructure of annealed cast bronze showing the thickness of the surface layer of cold-worked metal. $\times 100$

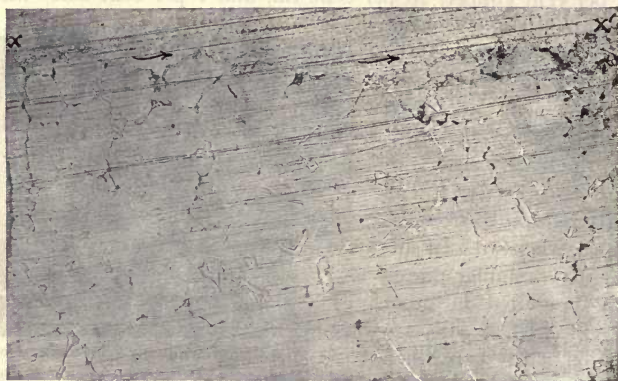
FIG. 28.—Microstructure of cast aluminum alloy showing the "path" of the fracture produced by a tensile stress. $\times 100$

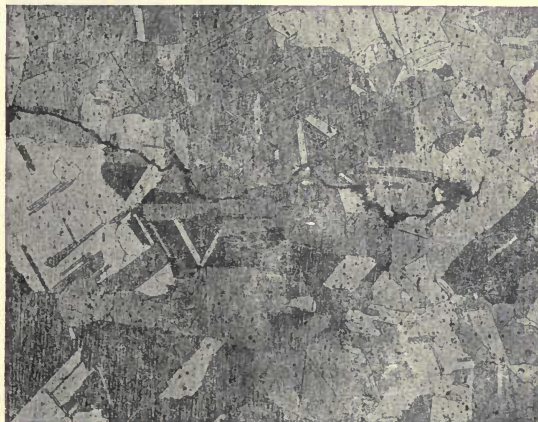
FIG. 46.—Microstructure of copper which was spoiled in annealing as a result of the nature of the surrounding atmosphere. $\times 100$

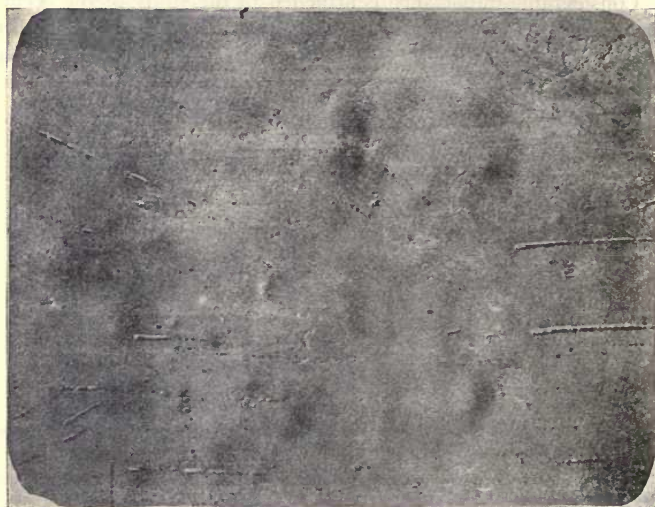
FIG. 49.—*Appearance of the exposed surface of corroded tinned copper sheathing used for roofing purposes. $\times 1$*

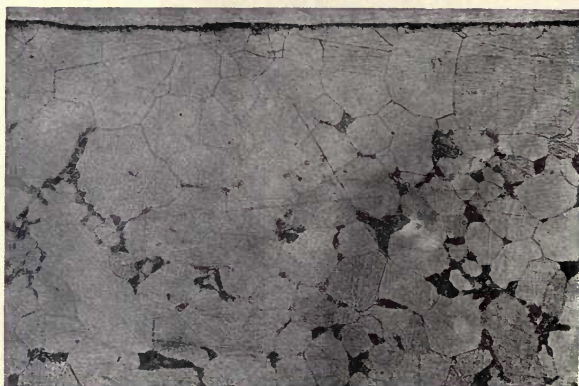
FIG. 51.—Microstructure of an iron-carbon alloy which was decarburized by heating in vacuo. $\times 100$

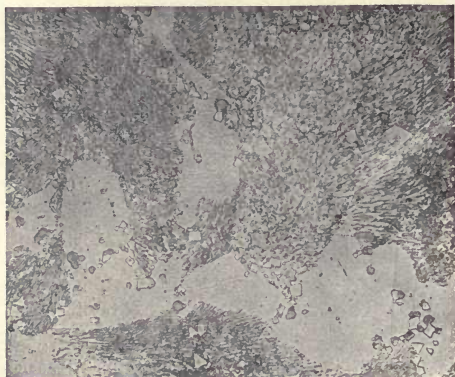
FIG. 53.—Microstructure of steel to which additions of zirconium have been made. $\times 500$
